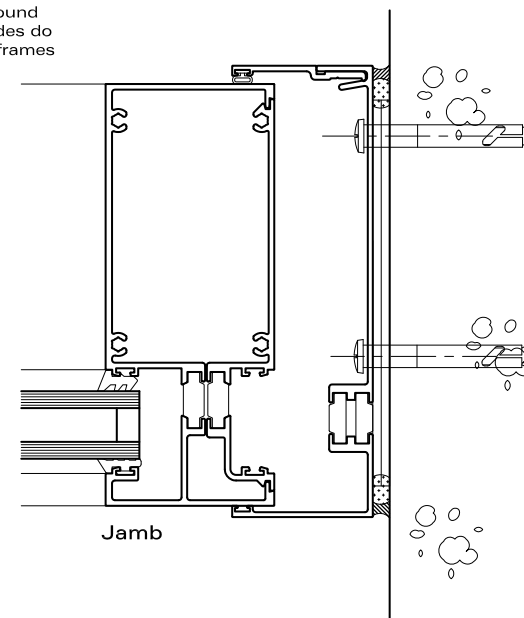
Jamb installation with thermally broken sub-jamb.
Using sub-frames all the way around makes it possible let the wet trades do their work then install the main frames and glass.
